OPTIMIZATION OF
WASTEWATER STABILIZATION PONDS
IN HONDURAS

SUBMITTED TO THE DEPARTMENT OF CIVIL AND ENVIRONMENTAL
ENGINEERING IN PARTIAL FULFILLMENT OF THE REQUIREMENTS FOR THE
DEGREE OF

MASSACHUSETTS INSTITUTE OF TECHNOLOGY

JUNE 2009

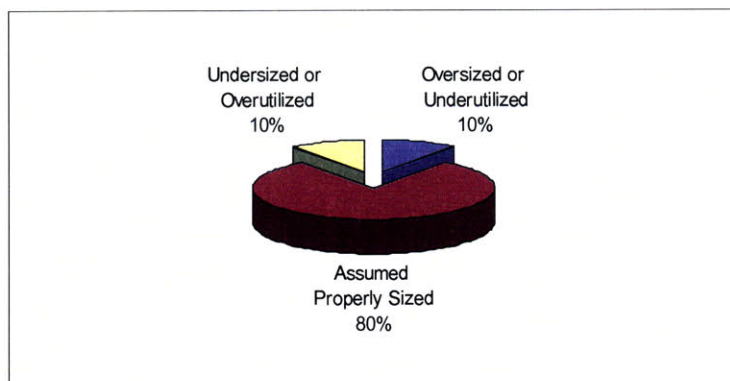
wastewater sources were of concern. For instance, Puerto Cortés reported high flows and shortened residence times during rainfall events due to illegal storm sewer connections. Overall, of the ten visited systems currently on line, only 80% were assumed to be properly sized, as illustrated in Figure 4-2.

Figure 4-2: System Sizing Efficiencies

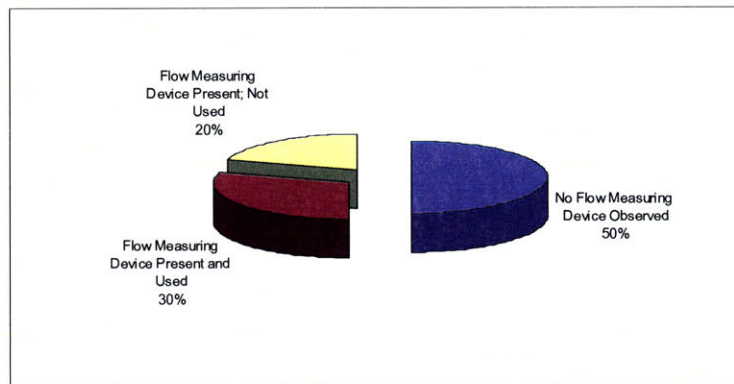
Flow monitoring practices were reported at at least four locations. Flow measurement devices were present at several other facilities; however, these were not found to be used (Figure 4-3). In addition, irregular flow patterns were observed in several cases. At the pond system in Talanga, flow into the maturation pond was visibly unbalanced between two inlet pipes. When this issue was brought to the operator's attention, it was found that the system valves were not capable of completely balancing this flow. Further, the facility operator and director did not appear concerned with balancing the flow. Since flow balance is linked to pond performance, it could be reasonably speculated that this imbalance negatively impacts the effluent quality at this pond.

Figure 4-3: Examination of Flow Measurement Device Distribution and Usage

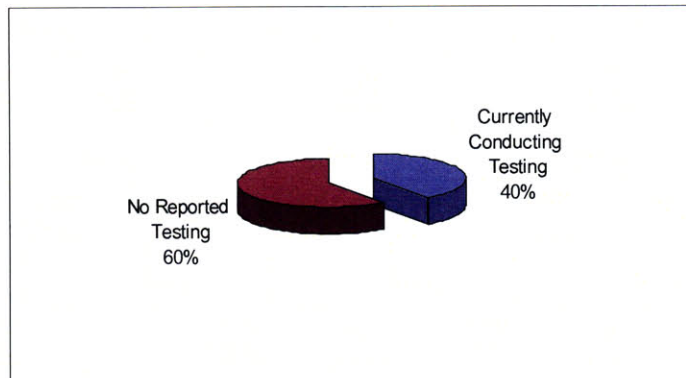
Routine water quality monitoring was directly observed in two cities. The final effluent from these facilities was reportedly compliant with regulatory requirements. Two other facilities reported that quality testing is routinely performed. Five facilities confirmed that they were not performing water quality testing, and a sixth site did not report such testing. In the case of the ponds in Choloma, the plant director is currently seeking guidance regarding water quality parameters and testing protocols, and no testing is being performed at this time. Quality monitoring observations are summarized in Figure 4-4.

Figure 4-4: Water Quality Monitoring Distributions

Testing need not be difficult, but should be implemented routinely in order to monitor system function and ensure discharge quality standards are met. Mara (2003) states that:

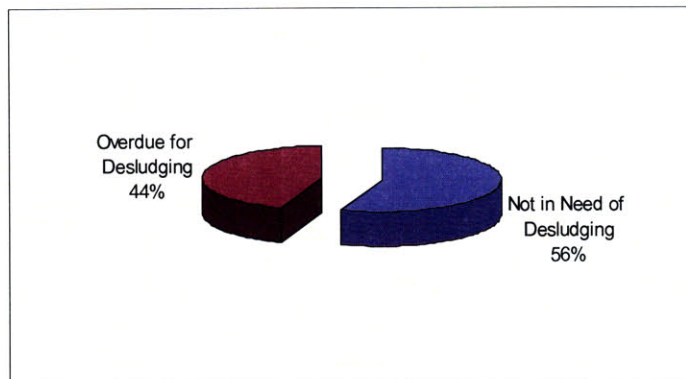
Of the facilities visited, a number were recently brought into operation and have not yet needed to carry out desludging (Figure 4-5). Facilities such as La Lima and Puerto Cortés have been monitoring sludge depth and are reportedly in the process of developing a sludge management plan. Puerto Cortés anticipates desludging its anaerobic ponds at some point in 2009.

Figure 4-5: Distribution of System Time Horizons for Desludging

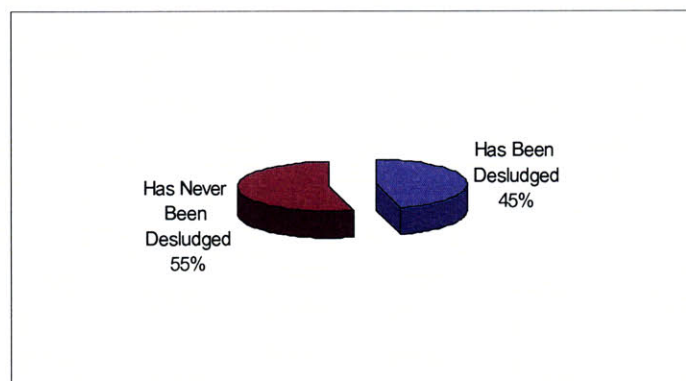
The systems at Tela, Teupasenti, and Las Vegas reportedly have been desludged although not necessarily on a routine basis (Figure 4-6). Sludge at Tela was dried and buried onsite in 2007. Drying beds were used for sludge management at Teupasenti. None of the facilities surveyed has been successful in implementing or marketing sludge for beneficial reuse.

Figure 4-6: Distribution of Systems Which Have Been Desludged

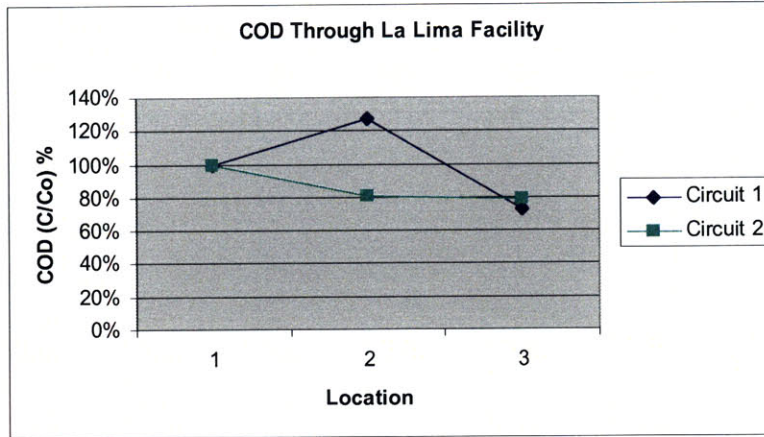
Figure 7-1: COD Removal Through La Lima Facility

It should be noted that the spike in Circuit 1 COD to above-headworks levels is unexpected and is likely due to a flaw in this data collection. The activity of collecting sludge depth measurements created significant agitation in the ponds, and was seen to resuspend some sediment. It is not unreasonable to suspect that this may have occurred more at one pond than the other, and it is plausible that the resuspended organic matter could account for the some or all of the inflated COD found in those samples.

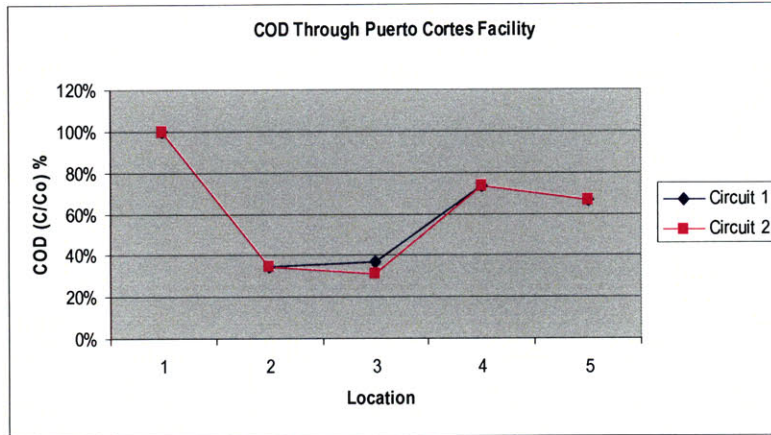
Figure 7-3: COD Removal Through Puerto Cortés Facility

Again some readings were found to be suspect and may indicate irregularities in the data collection. The COD level was found to step up significantly in effluent from Maturation Pond # 1, and it does not lower appreciably after Maturation Pond # 2. There was no stirring activity through sludge depth measurements in the implicated ponds, and the pattern is consistent through several ponds. Additionally, this pattern is sustained through the three tests run on each water sample at each location. This may be indicative of increased algal cell growth on the hot, sunny afternoon when sample collection was conducted, the first such day after an overcast and rainy week. Further investigation would be necessary to fully understand the cause for this spike in COD.

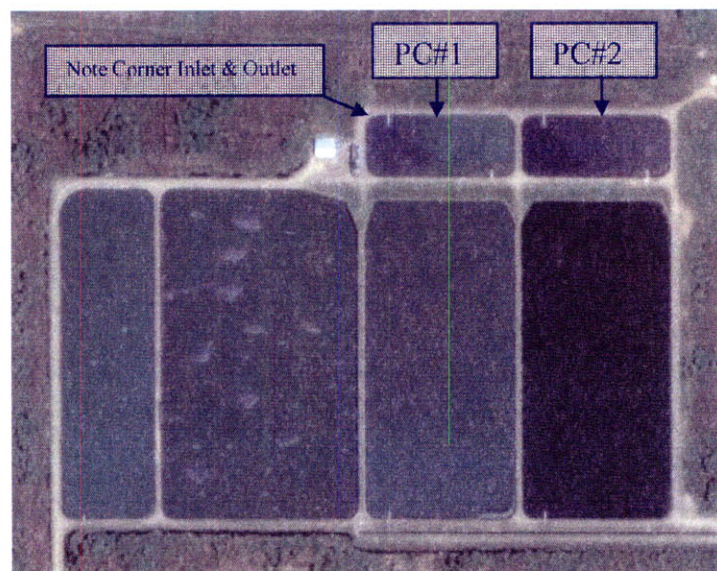
Figure 7-9: Satellite Image of Puerto Cortés Ponds
(Source: Google Earth)

These Peclet numbers indicate more mixing in the ponds at Puerto Cortés as contrasted with those at La Lima. This is not a surprising finding, as the Puerto Cortés design involved much deeper ponds with a roughly similar footprint. Additionally the presence of a single inlet and outlet in the corners at Puerto Cortés might less effectively achieve a plug flow regime than the pair of inlets and outlets at opposing ends of the ponds at La Lima. As expected, the Puerto Cortés pond curves coincided exactly with one another, while the curves for the La Lima ponds were slightly different. La Lima Pond # 1 performed slightly better with slightly less mixing as evidenced in the numerical model output. The only difference between the virtual ponds, as with the real constructed ponds, was the wider placement of outlets in La Lima Pond # 1, as can be seen in the satellite image shown in Figure 7-8. Figure 7-9 depicts a satellite image of the Puerto Cortés ponds with the corner placement of inlet and outlet clearly visible.

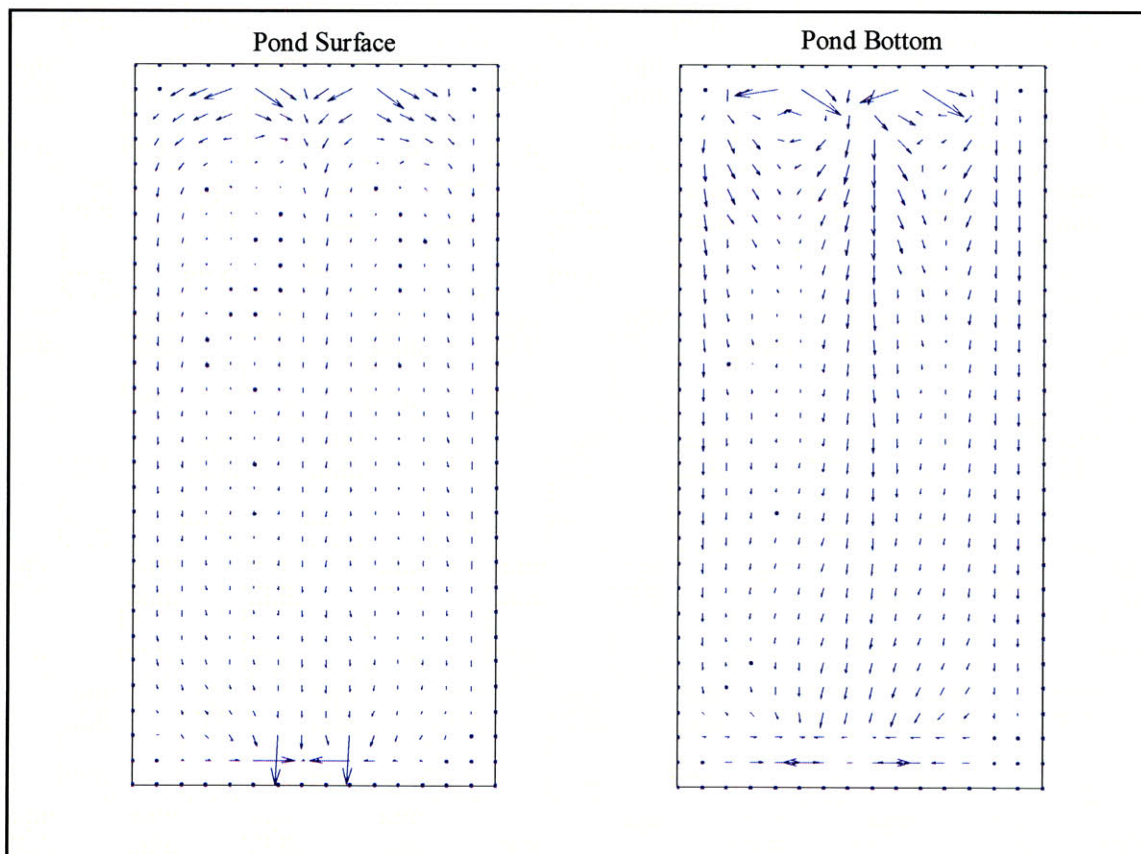
One concern with uneven sludge is the uneven flow patterns it can affect and the subsequent potential for short circuiting. The notion of short circuiting in an uneven sludge distribution is supported by the velocity vector fields for the La Lima pond. Figure 7-13 depicts the La Lima pond water velocities for surface and bottom when sludge fills 40% of the pond volume. Channels of larger arrows indicating more rapid streamlined flow are seen in the sidelines and center of the pond, most dramatically on the pond floor.

Figure 7-13: La Lima 40% Sludge Flow Velocities

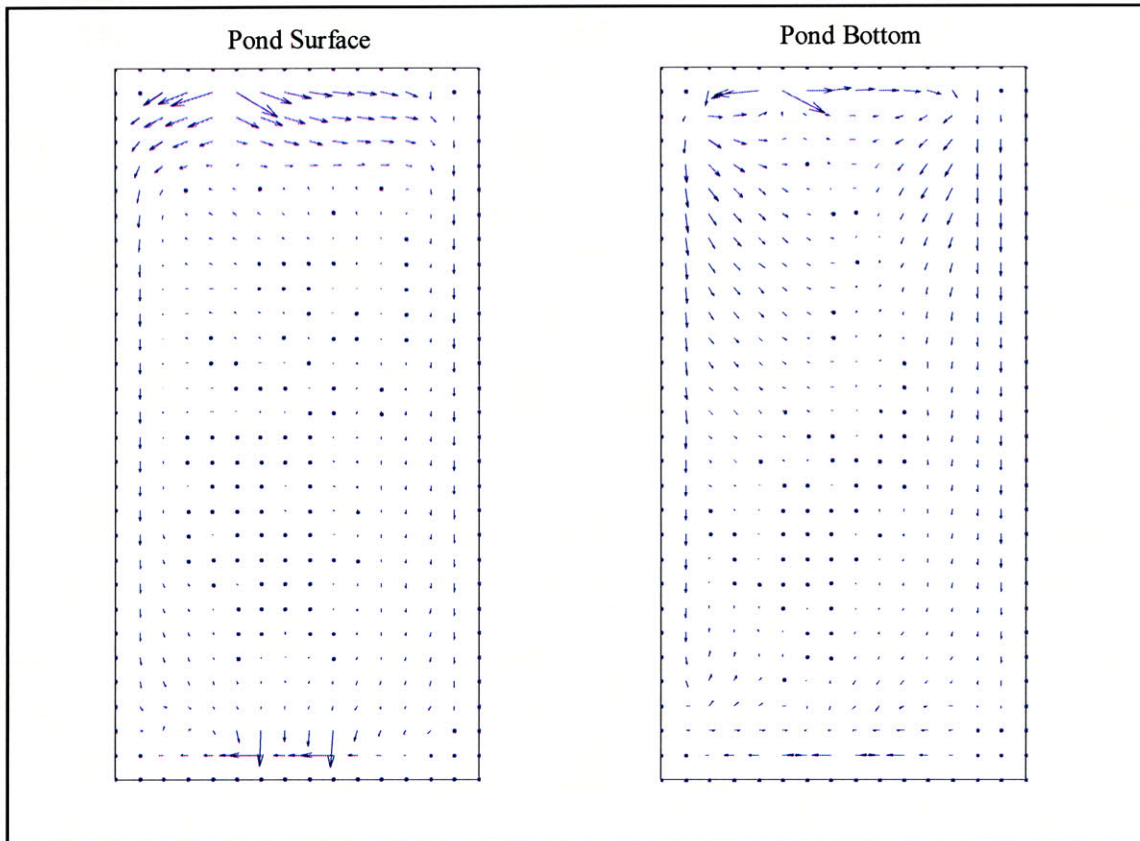
To represent the short circuiting, the INTROGLLVHT model outputs for surface and bottom velocities are presented as vector fields in Figure 7-14. Upon examination, the vector fields support the hypothesis of short circuiting flow, showing large pockets of unmoving water (indicated by dots instead of arrows). The vector fields also depict distinct channels of more rapidly moving water represented by arrows which align down the sidelines of the surface and base of the pond. This trend for short circuiting of unbalanced flow was observed in vector fields for all sludge depths and distributions, and became exaggerated with sludge accumulation.

Figure 7-14:La Lima As Built Flow Velocities - Unbalanced Flow

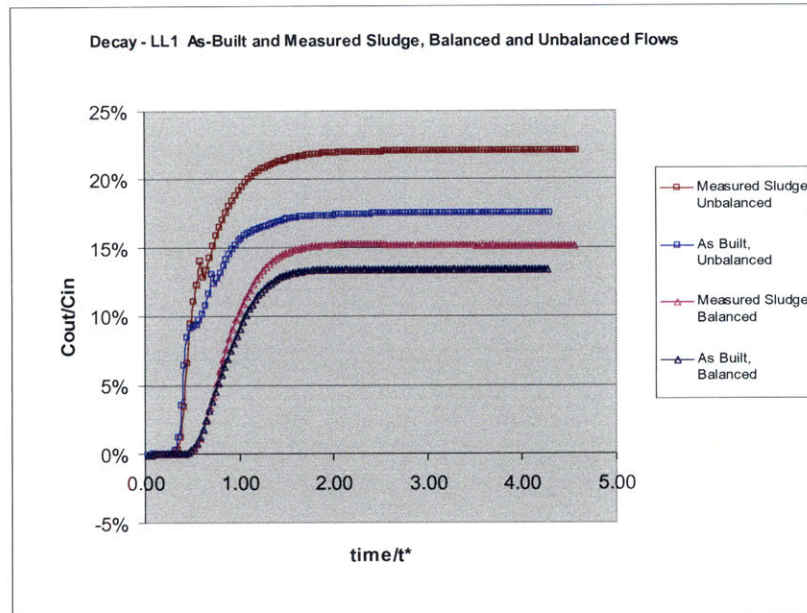
Figure 7-15: La Lima # 1 - Balanced vs. Unbalanced Flow

The results in this chart are striking. As an anticipated effect, the as-built pond outperforms the measured sludge pond, attributable in part to increased mixing and more significantly to decreased retention time in the measured pond. It may have also been anticipated that the ramp up interval would exhibit erratic behavior as demonstrated in this chart with unbalanced flows, similar to the erratic ramp up seen in the non-decay case. But most striking is the deterioration of pond performance at steady state with unbalanced flows, and the antagonistic effect that uneven sludge has on this deterioration. Whereas the presence of sludge led to a cost of two percentage points in removal efficiency with balanced flows (13.4% to 15.2 %), this cost was nearly five points in the unbalanced flow case (17.5% to 22.1%). And in the comparison within a single bathymetry, simply balancing the flow could net about four percentage points of further improved performance in the as-built case (17.5% to 13.4%), growing to a six percentage point gain if sludge is present (22.1% to 15.2%). The specific percentages are unique to the set of assumptions that inform this model, but the trend indicated by these percentage distributions is instructive for pond operation generally. As stated previously, all model concentrations are summarized in Table 7-4. These factors point to the importance of maintaining symmetric and balanced flows within a system.
